# IN WATER INVESTIGATION REPORT

## BRADFORD ISLAND LANDFILL Cascade Locks, Oregon

March 2002

**U.S. Army Corps of Engineers, Portland District**  
333 SW First Avenue  
PO Box 2946  
Portland, Oregon 97208-2946

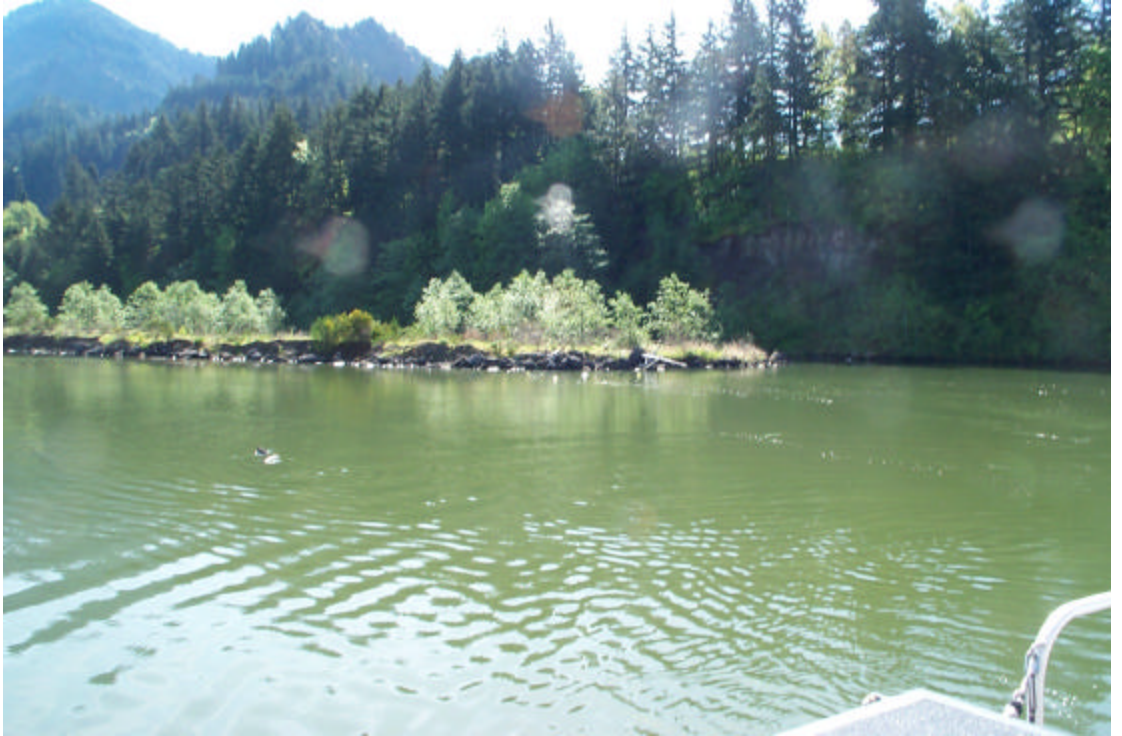
USACE		<b>Site Location:</b> Bradford Island Landfill, In-Water Investigation	<b>Project No.</b> 52-00080001.04
<b>Photo No.</b> 2.4-1	<b>Date:</b> May-01

<b>Direction Photo Taken:</b>  Southwest			
<b>Description:</b>  Goose Island: Background Sampling Location

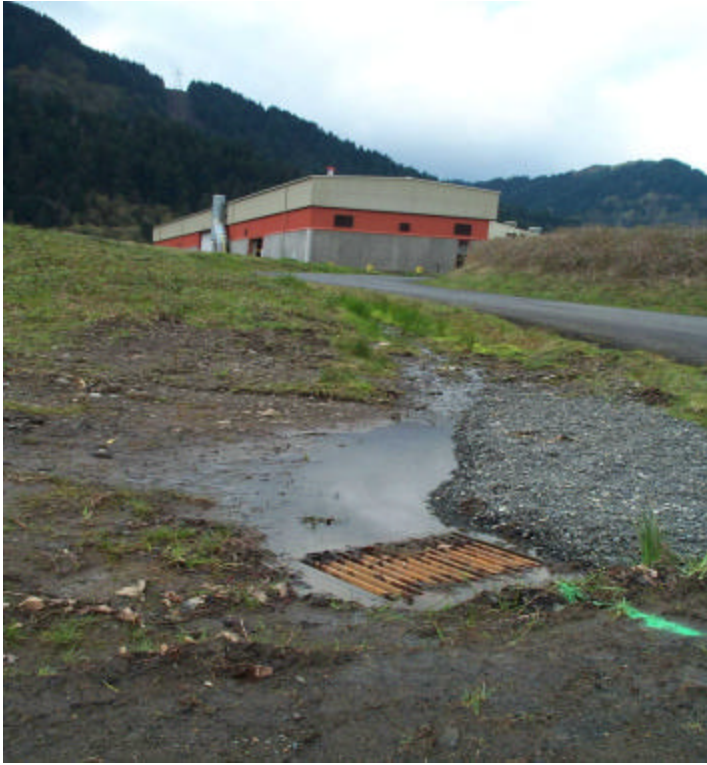
USACE		Bradford Island Landfill, In-Water Investigation	52-00080001.04
<b>Photo No.</b> 2.6-3	<b>Date:</b> Mar-01

<b>Direction Photo Taken:</b>			
South			
<b>Description:</b>			
Sandblast Building Drain Catch Basin #2

Contaminants found in the catch basins near the Sandblast Building appear to have impacted the sediment collected directly below the catch basin outfalls in the Columbia River. The contamination consists of mostly the same PCB, PAH and metals compounds in the drain samples (Tables 4-11, 4-13 and 4-15). In addition, the PCB Aroclor found in the catch basins and the sediment below the outfalls in the sandblast grit area (Aroclor 1260) is the same Aroclor found in the transformer fluid spilled at this location in 1995. This differs from the sediments adjacent to the landfill, where Aroclor 1254 was detected.

The USACE removed the sediment within the drain lines, and replaced the felt “socks” that lined the associated catch basins in October 2001. Additionally, the area surrounding the catch basins is currently being evaluated as part of the upland investigation.

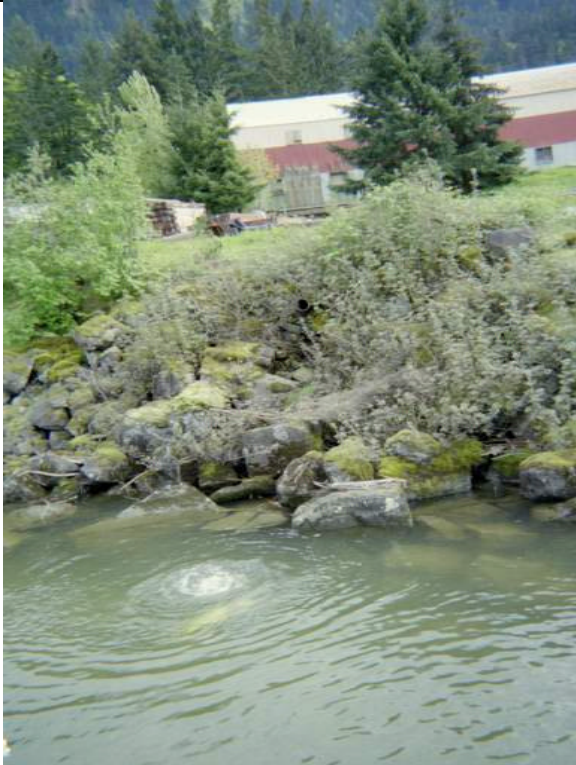
<b>Photo No.</b> 2.6-6	<b>Date:</b> May-01

<b>Direction Photo Taken:</b>			
Southwest			
<b>Description:</b>			
Diver's Bubbles. Sediment sampling under Sandblast Building Drain Outfall #1.

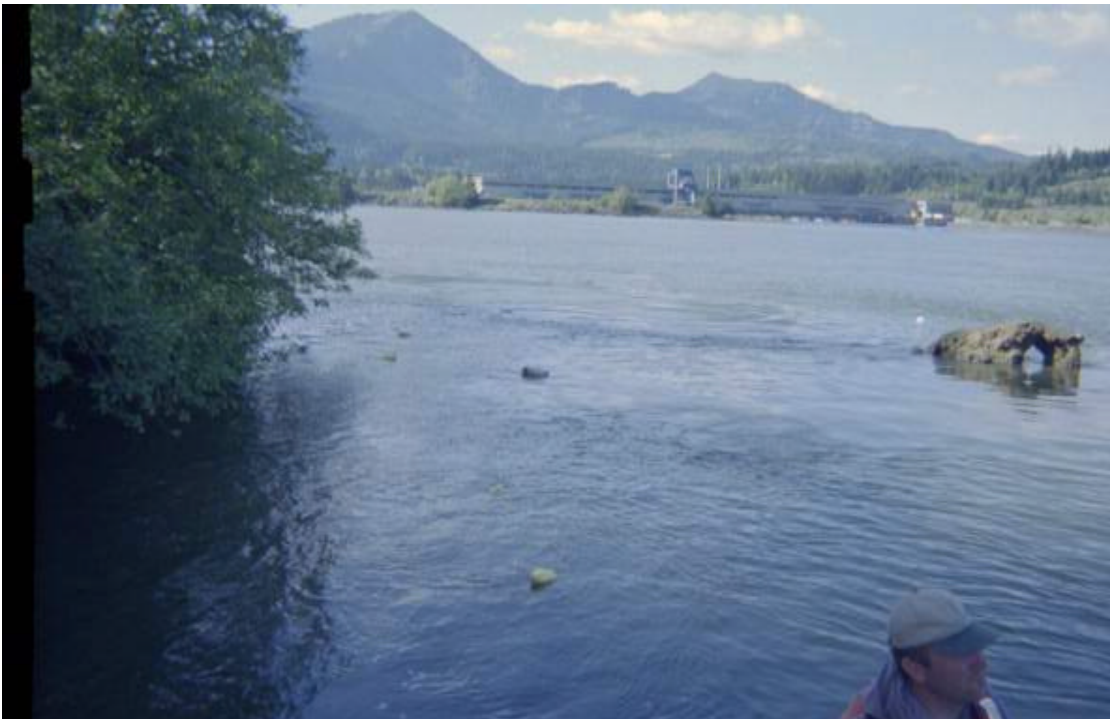
USACE		<b>Site Location:</b> Bradford Island Landfill, In-Water Investigation	<b>Project No.</b> 52-00080001.04
<b>Photo No.</b> 2.4-3	<b>Date:</b> May-01

<b>Direction Photo Taken:</b>  Northwest			
<b>Description:</b>  Upstream Debris Pile SPMD Anchors and Crayfish Traps
